ARCHAEOLOGICAL ASSESSMENT OF THE DESIGNATED WRECK OF THE *NORTHUMBERLAND* ON THE GOODWIN SANDS

PROJECT REPORT 2018

Ref: 7700

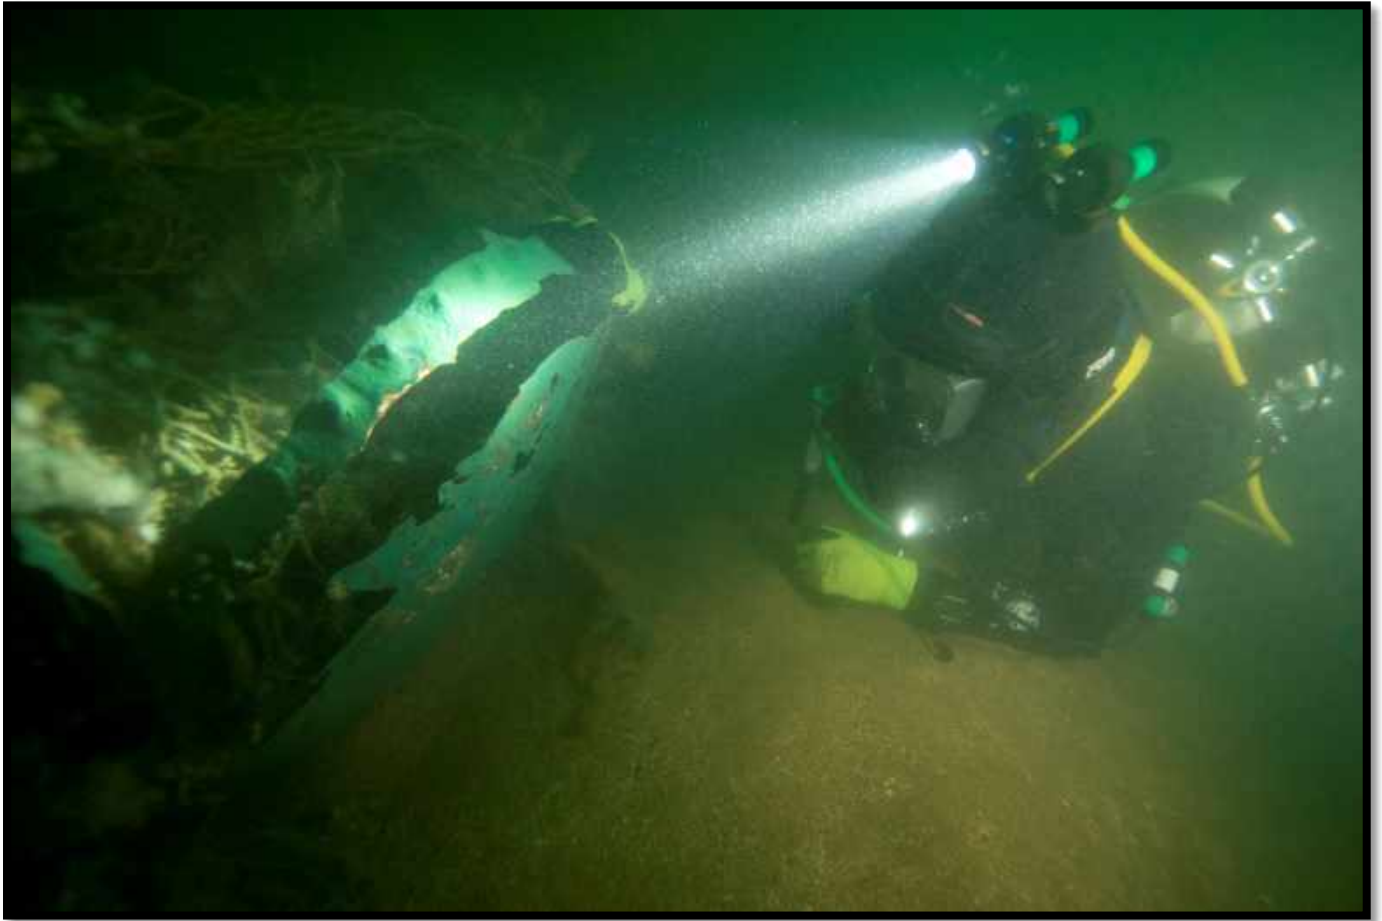
- 4.2.6. Beginning at the bottom of the west side of the feature there is a large riveted copper vessel lying on its side. It is in poor condition with part separation between the sides and base of the vessel. The diameter of the vessel measured from its base is 600mm. It is entangled with fishing net, which has probably contributed to its poor condition (Figures 4 and 5). This has been exposed previously and recorded on past site plans and reports (Pascoe *et al* 2015, 135 & WA 2010, 8). These previous site plans and reports have described it as a twin copper cauldron. This suggests there has been significant deterioration or even loss of one of the vessels previously seen.

Figure 5: Diver inspecting the copper vessel. Notice the amount of fishing net entangled with it.

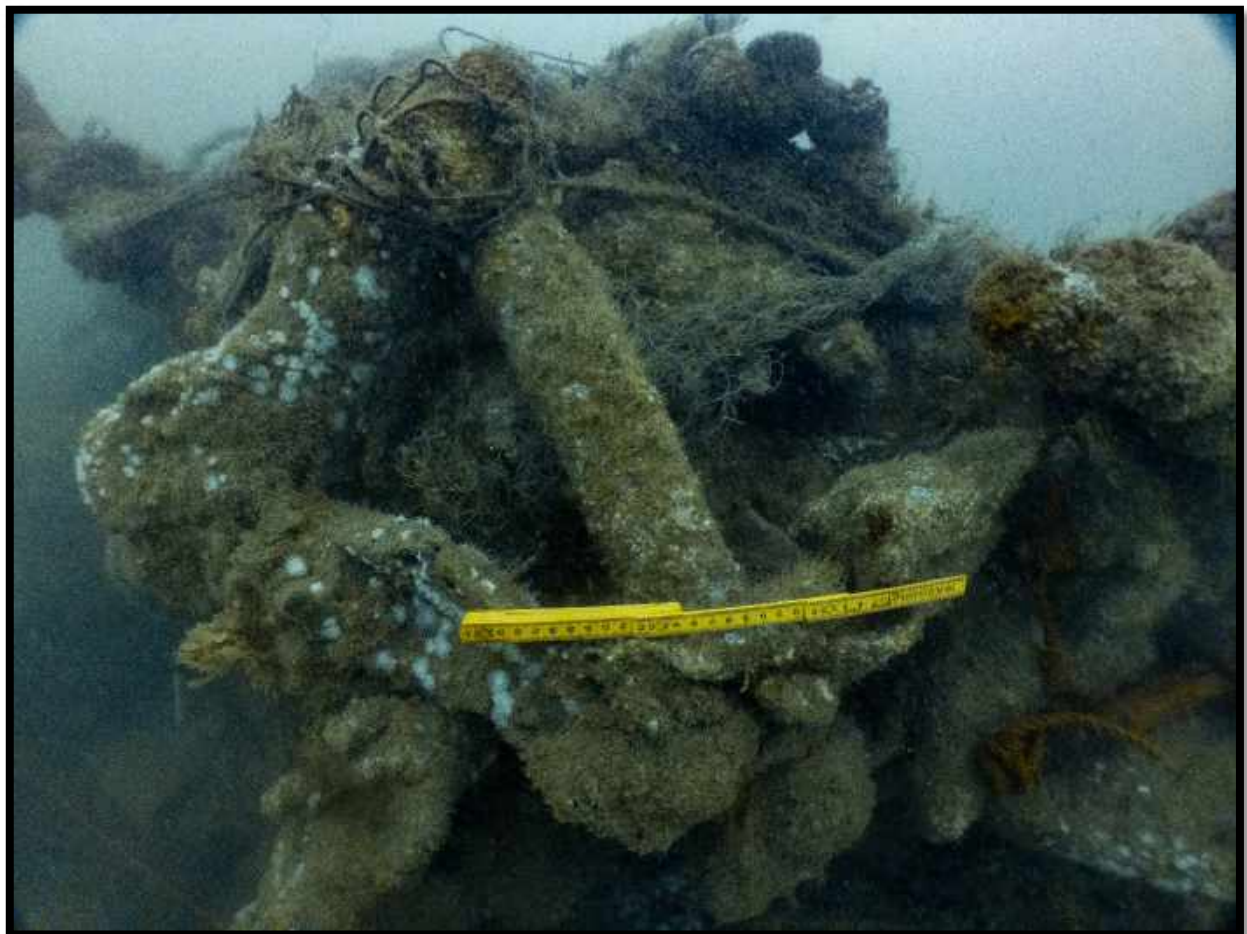
- 4.3.4. As mentioned above, a lead scupper was identified near the top of the concretion. Scuppers were found on the sides of the hull at the level of the main gundeck. This was the first deck above the waterline and allowed unwanted water to drain out of the ship. The location of the scupper could suggest that the side of the vessel was, at some point, present here, but has since eroded away.

Figure 6: Image of lead scupper near the top of the concretion.

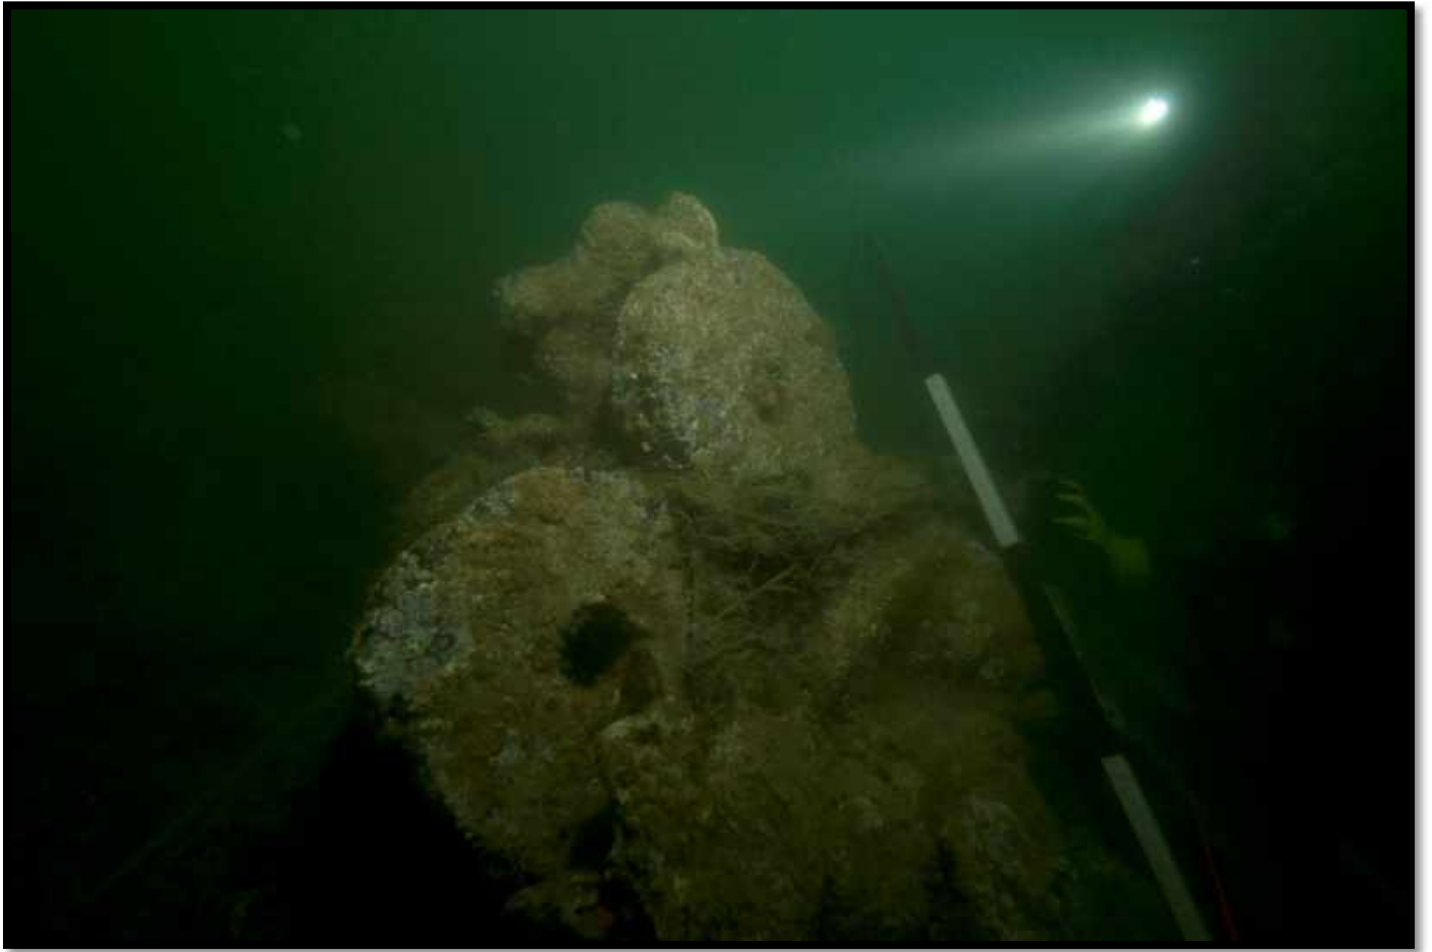
- 4.2.10. Continuing around the base of the concretion, approximately 3m to the northeast, is a concreted group of at least three pulley sheaves. The top two sheaves are clearly visible and have a diameter of 300mm, and a thickness of 60mm. The holes at their centres have a diameter of 60mm. Below these two sheaves, the edge of a third sheave can be made out. Tangled around the sheaves and surrounding concretion is gill netting with small floats attached. Further netting with floats can be seen coming out of the sand and floating up to 300mm above the surrounding seabed (Figures 10 and 11).

Figure 10: A diver inspecting a group of pulley sheaves at the SE end of the site. Photo by Michael Pitts.

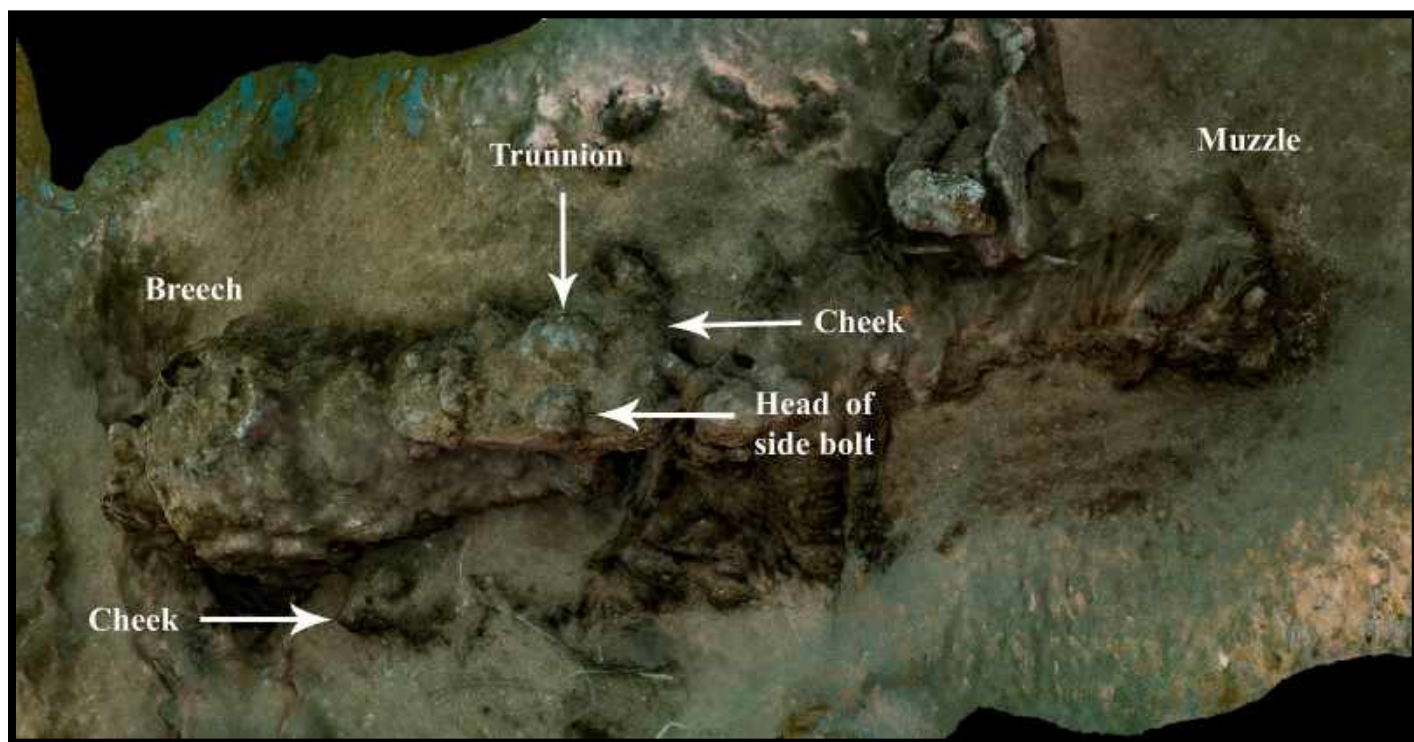
- 4.2.17. Gun 3 also has the remains of its associated carriage attached. The gun lies on its side, and the upper side has a small section of the carriage cheek surviving from around the trunnion recess. This extends back to the first step of the cheek. Below the trunnion recess are the remains of the iron side bolt, which extends down under the belly of the gun and into the other cheek. The bottom edge of this cheek can just be seen protruding from the sand and it extends a little further back than the upper cheek (Figures 16 and 17). The bed of the carriage is missing. The surviving parts are consistent with a truck carriage. This type of carriage has two stepped cheeks, fastened to a wooden bed, with two wooden axles and four trucks (wheels). Similar examples have been recovered from the wrecks of the *Stirling Castle* (1703) and the *London* (1665) (Pascoe 2018, 46 and McElvogue 2008, 42).

Figure 16: A photogrammetry model of Gun 3 showing the survival of parts of its associated gun carriage. The gun is lying on its side with the remains of parts of both cheeks present.

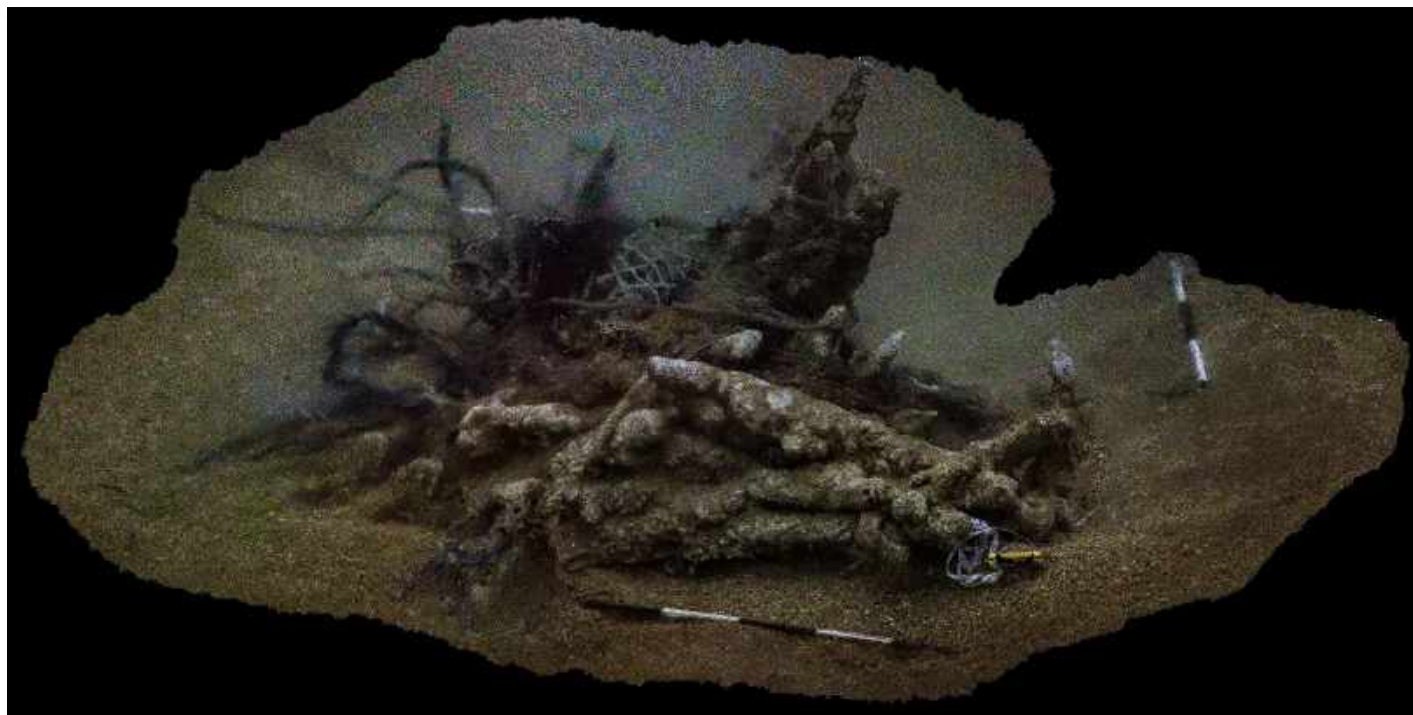
Figure 18: An orthophotomosaic of the assemblage of swords looking down. The scales are 1m with 10 and 20 cm increments. There is a lot of net entangled around the swords sticking up.

- 4.3.9. The discovery of the assemblage of swords was an unexpected find. The photogrammetric model clearly shows that there is the potential for many swords to be among this feature. According to the gunner's stores of the *Lennox*, the sister ship to the *Northumberland*, there should be 40 swords and 40 hangers (Endsor 2009, 164). Hangers had a slightly curved blade, which appears to fit with the shape of the concretion recovered; this could be a very significant find. This assemblage needs all the fishing gear to be removed, so it does not cause any more damage and so it can be recorded properly.

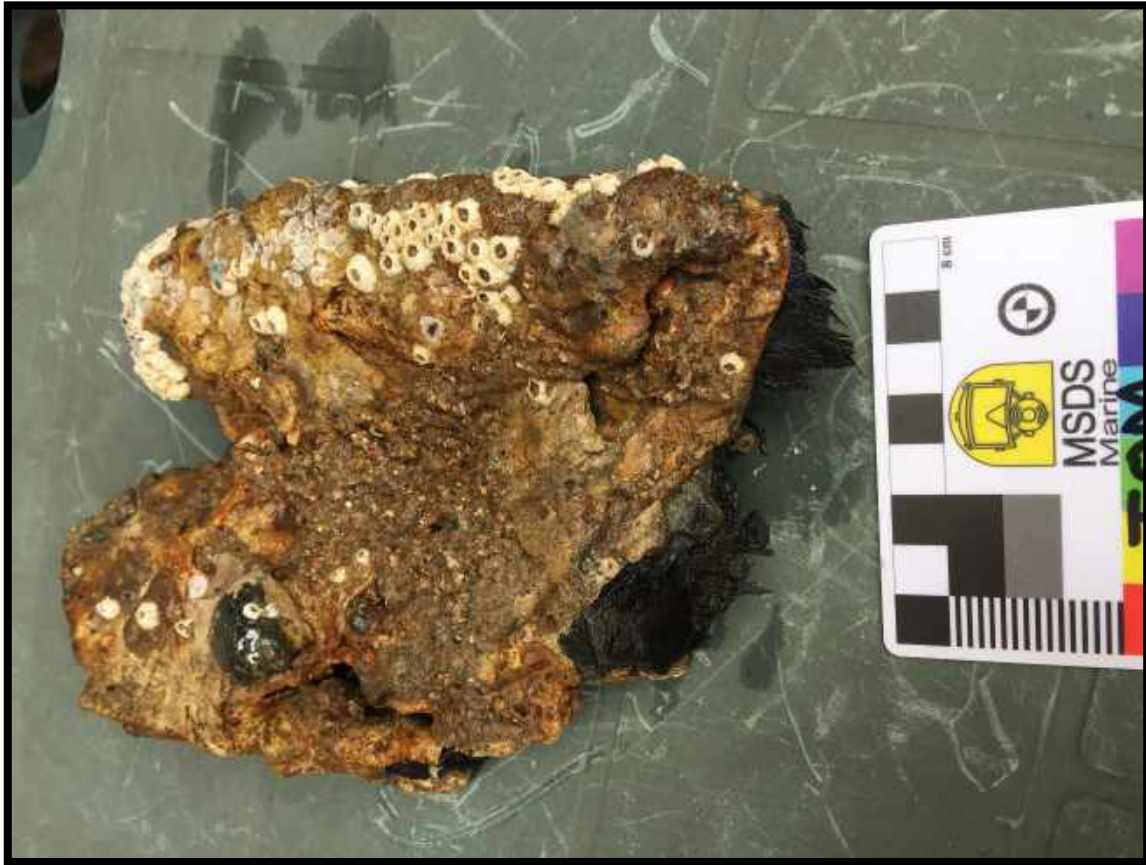
Figure 20: A photo showing the amount of fishing gear entangled around the assemblage. Photo by Michael Pitts.

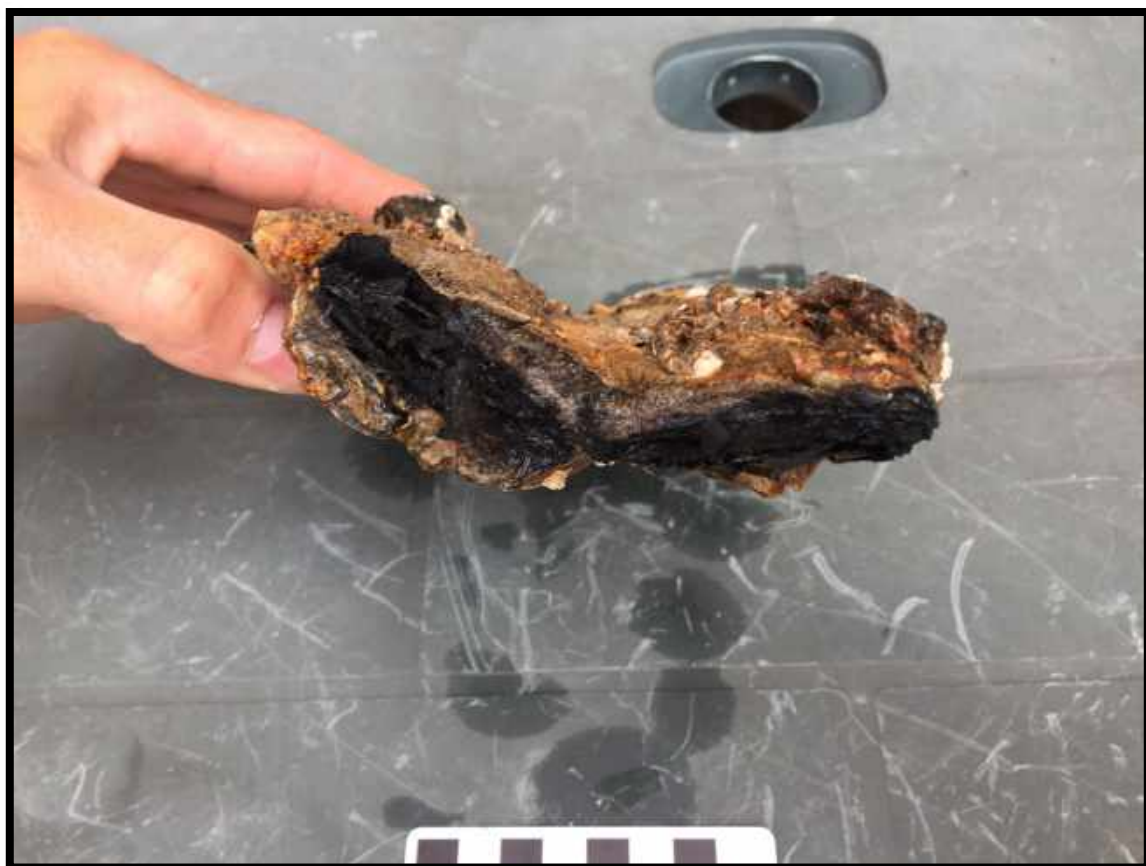
- 4.2.22. The fishing gear had damaged a small section of the feature. The damaged piece was at risk and vulnerable to loss and was therefore recovered. On closer inspection, following recovery, it was possible to see the shapes of three blades. Also, at the cross section, where it had broken away, it was possible to make out the remains of wood and leather scabbards (Figure 21 and 22).

Figure 21: Photo of the concretion recovered.

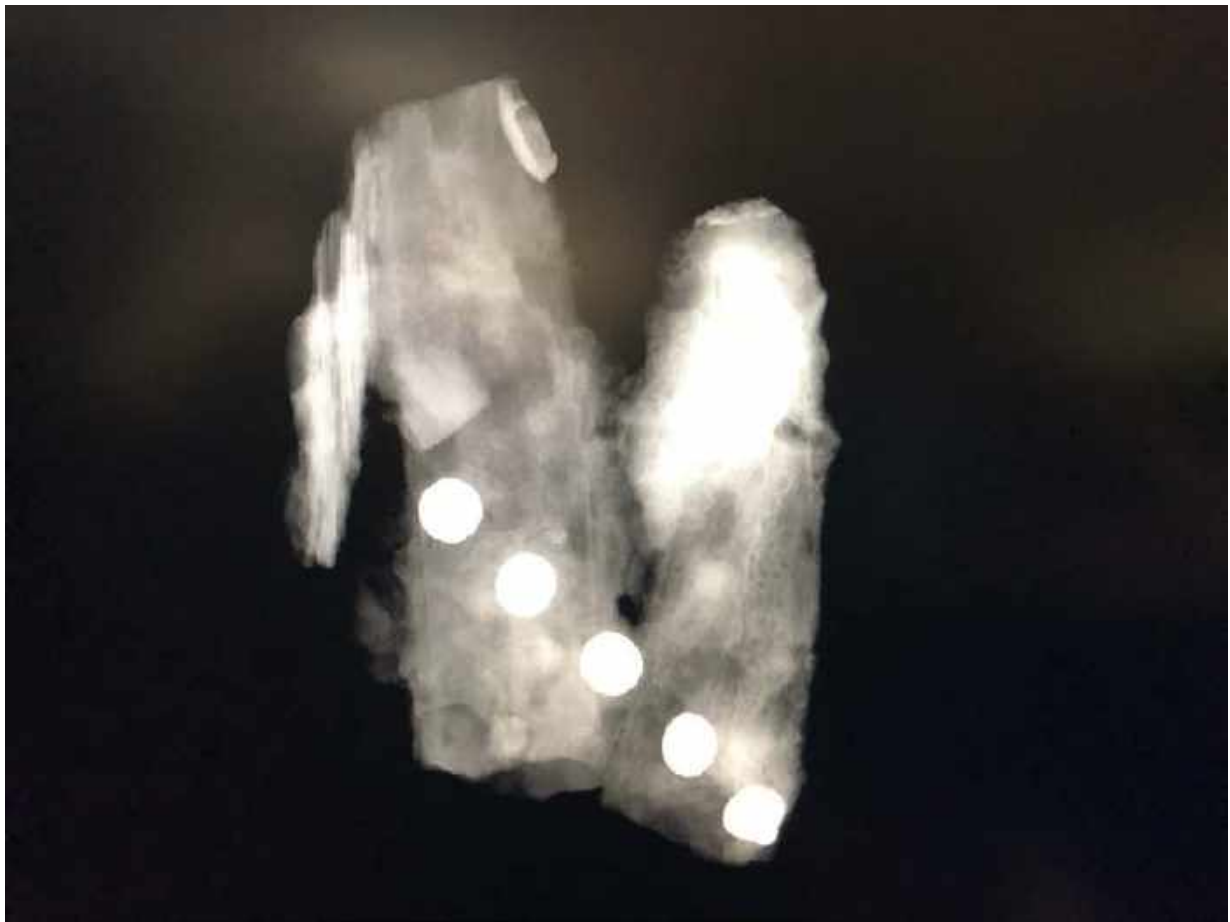
Figure 22: At the break wood and leather can be seen.

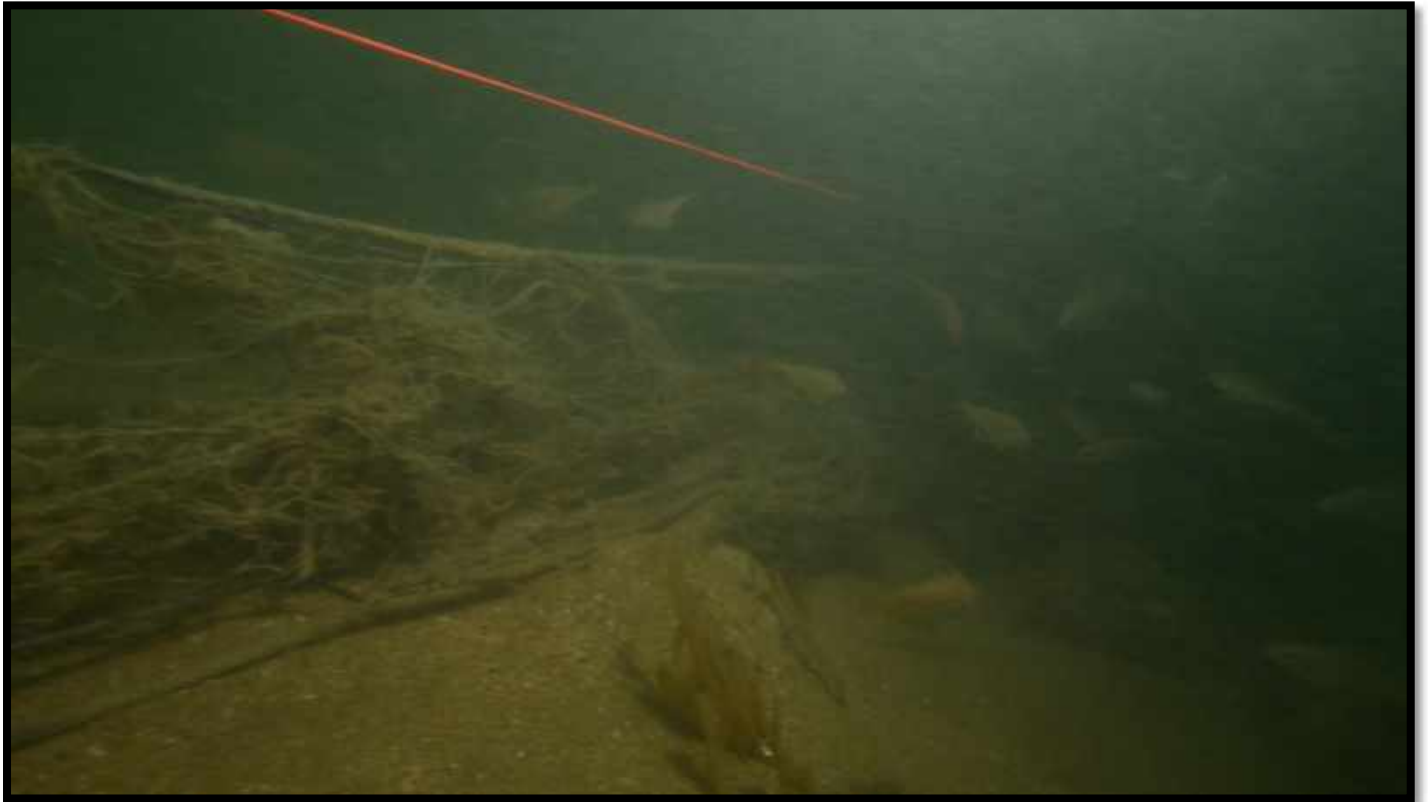
- 4.2.26. Considering the *Northumberland* is a designated site it was extremely alarming to find that all exposed features of the wreck were covered in fishing gear. The gear consisted of a variety of different types including: heavy robust trawl netting; lobster pots and their accompanying ropes; and, most alarming, a large amount of gill netting. The gill netting is particularly hazardous as it is made of an extremely fine nylon mesh with small floats attached. The floats enable it to float above the seabed making it a real entanglement hazard. On many areas of the site the net was floating up to 0.5m above the seabed (Figures 26-31).

- 4.2.27. We were extremely fortunate when we were diving that the visibility was reasonably good, which enabled us to see the net. The site and the Goodwin Sands, however, are renowned for poor visibility. In poor conditions divers generally crawl on hands and knees, rather than swim. With a lot of the gill net up to 0.5m above the seabed, it is therefore at just the right height for a diver to crawl into. This means diving the site in poor visibility is potentially extremely dangerous with risk of entanglement (Figures 26-31).

Figure 26: An example of the gill net floating above the seabed due to the small floats.

4.4.4. Considerable amounts of fishing gear were found entangled on areas of exposed wreckage and much of it was floating above the seabed. This is a serious entanglement hazard to divers, especially when the underwater visibility is poor. The author was contacted by HE regarding issuing a visitor's license to a dive club. At present it would be irresponsible to have divers who are unfamiliar with the site and potential hazards. The net is also a hazard to the archaeology and has already damaged the assemblage of concreted swords and the large copper vessel. The net is also obscuring the archaeology and hindering further recording and identification. The net is, therefore, both a risk to divers and the archaeology. PA strongly recommends returning to the site next year to remove the netting and therefore the danger to divers and the archaeology.

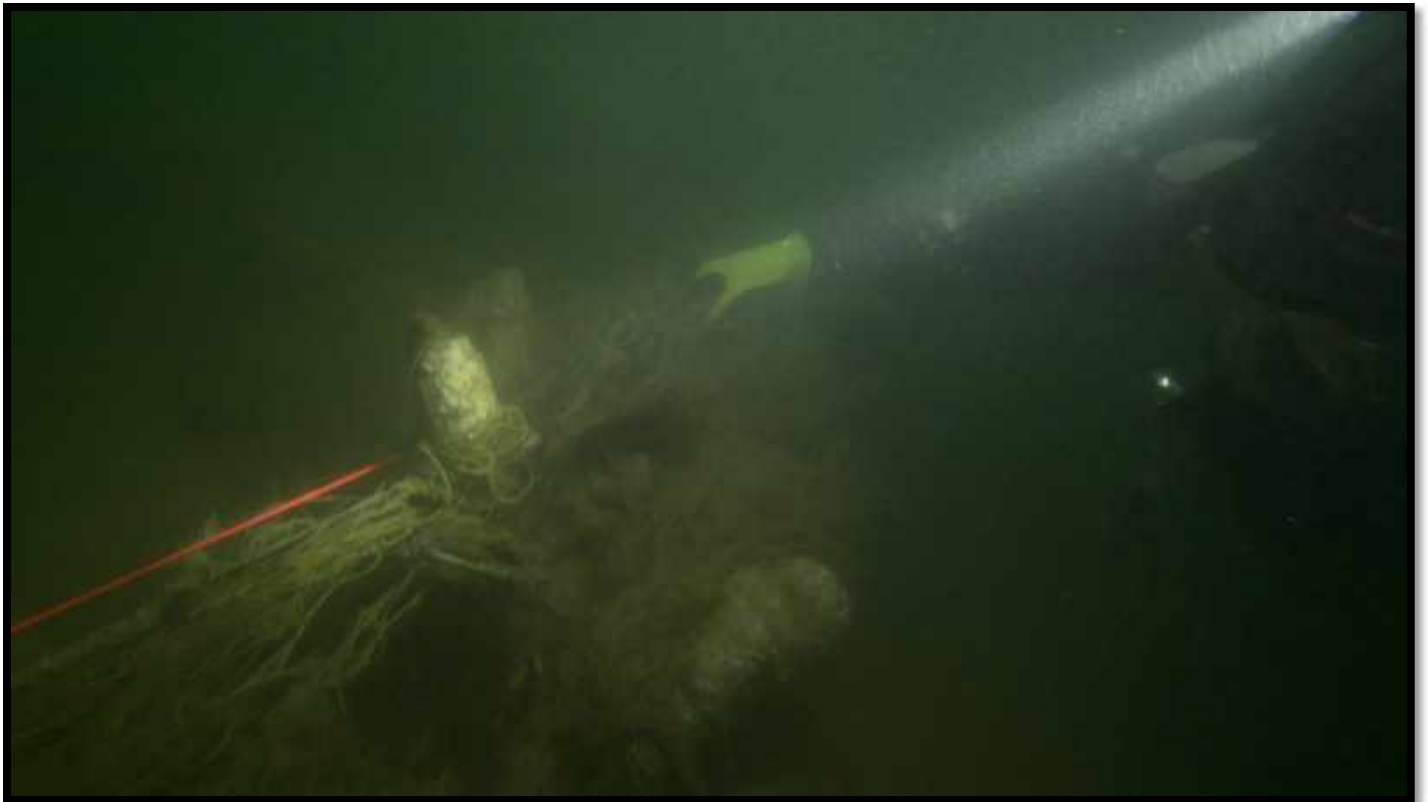
Figure 27: Gill net floating above the seabed.

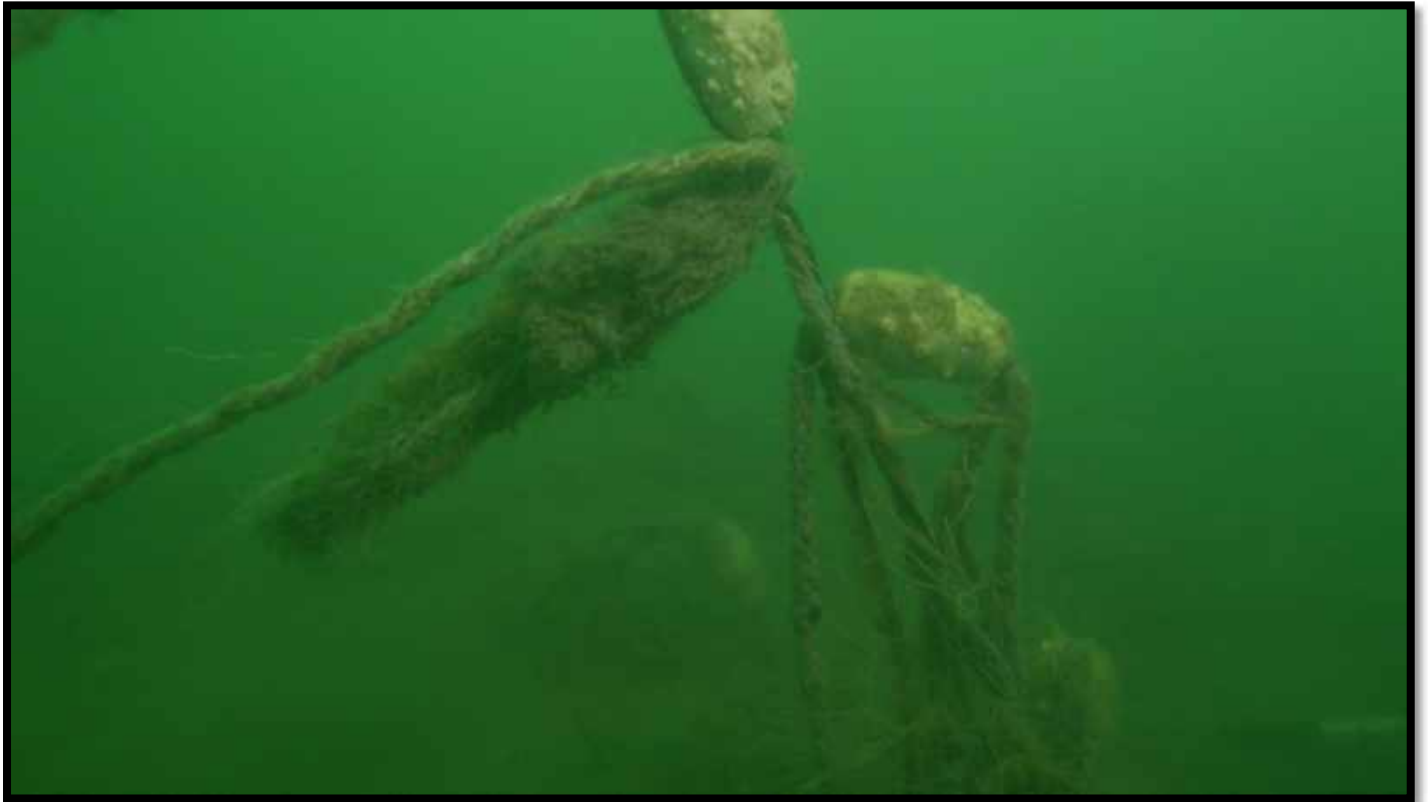
Figure 28: Diver holding a large bundle of gill net entangled on the wreck.

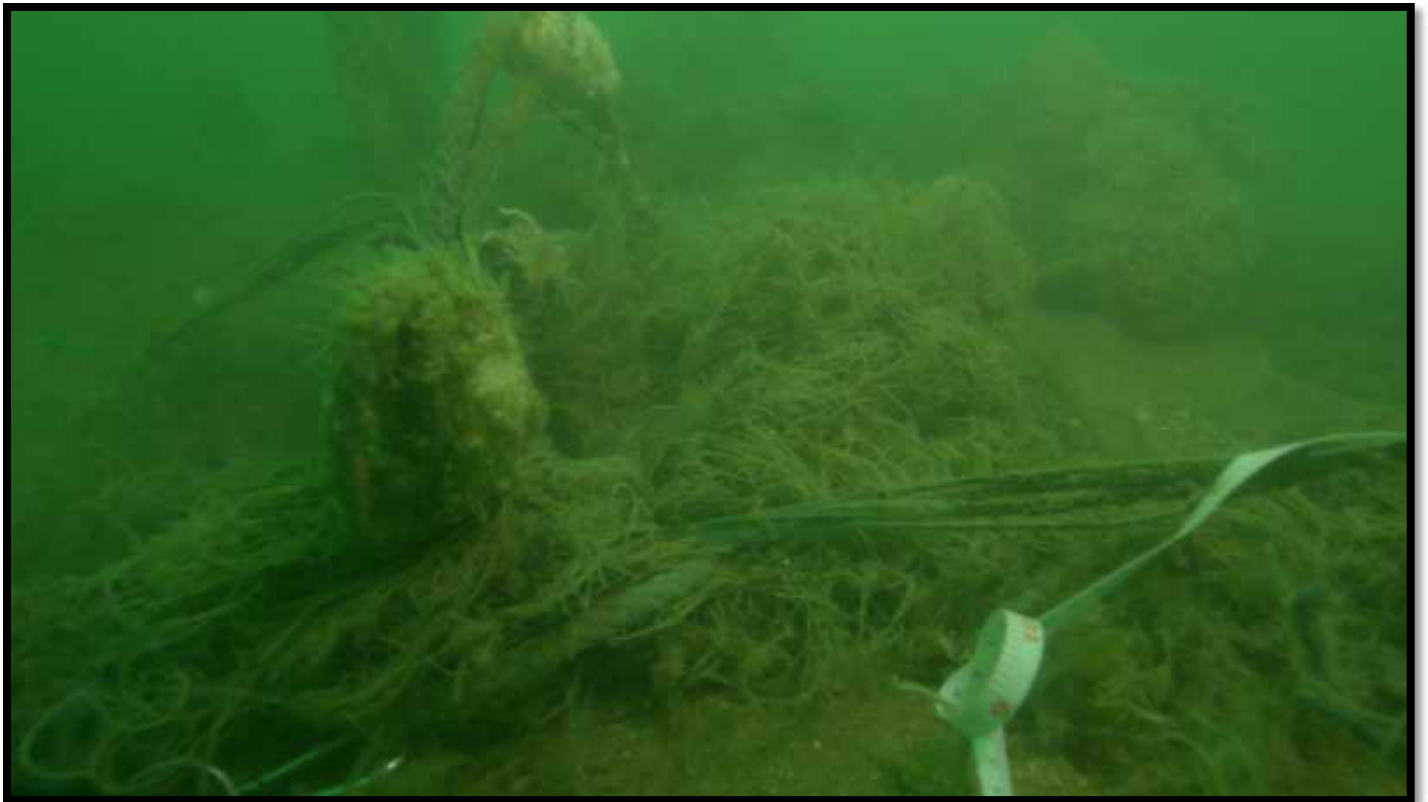
Figure 29: An example of the floats suspending the gill net above the seabed.

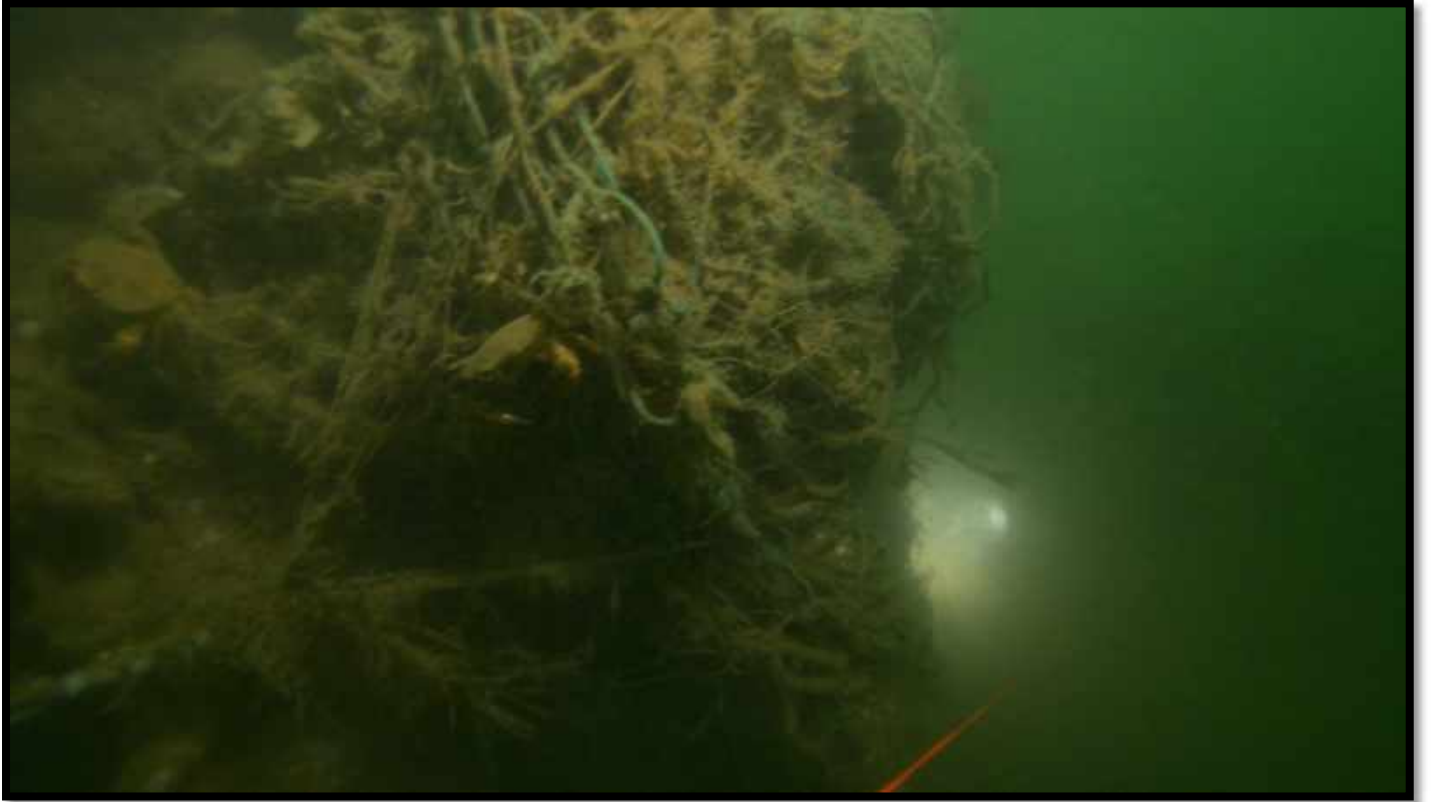
- 4.2.28. The entangled fishing gear is also a hazard to the archaeology. This is apparent from the poor condition of the copper vessel and the broken piece from the sword assemblage. Given that, in 2009, WA removed fishing net from this vessel to prevent further damage (WA 2010, 8), this net has come into the site since that time. The fishing gear is moving around the site with the movement of the mobile seabed, strong tides and currents, and during high energy storm events. This is clearly damaging the more fragile objects, but the sheer volume of netting is also obscuring the archaeology. While the net is there, many archaeological features are not easily recognisable and remain undetected.

Figure 30: Gill net and floats entangled on exposed features. This totally obscures the archaeology.
