ARCHAEOLOGICAL ASSESSMENT OF THE DESIGNATED WRECK OF THE *NORTHUMBERLAND* ON THE GOODWIN SANDS

PROJECT REPORT 2018

Ref: 7700

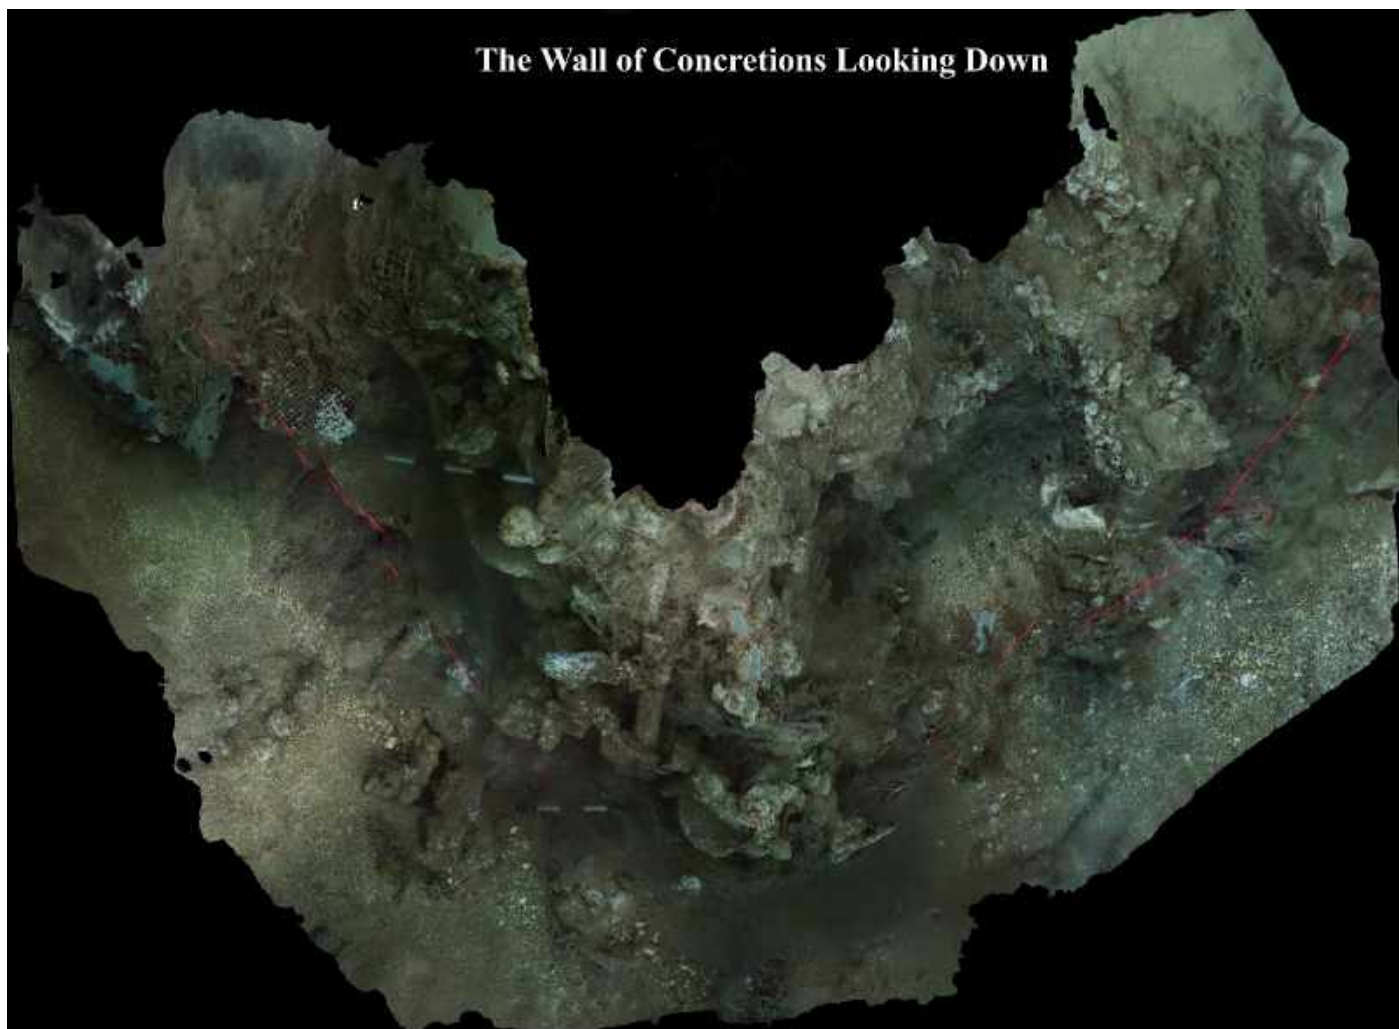
Figure 3: An orthophotomosaic of the plan view of the wall of concretion at the SE of the site. The scales in the image are 1m with 20cm increments.

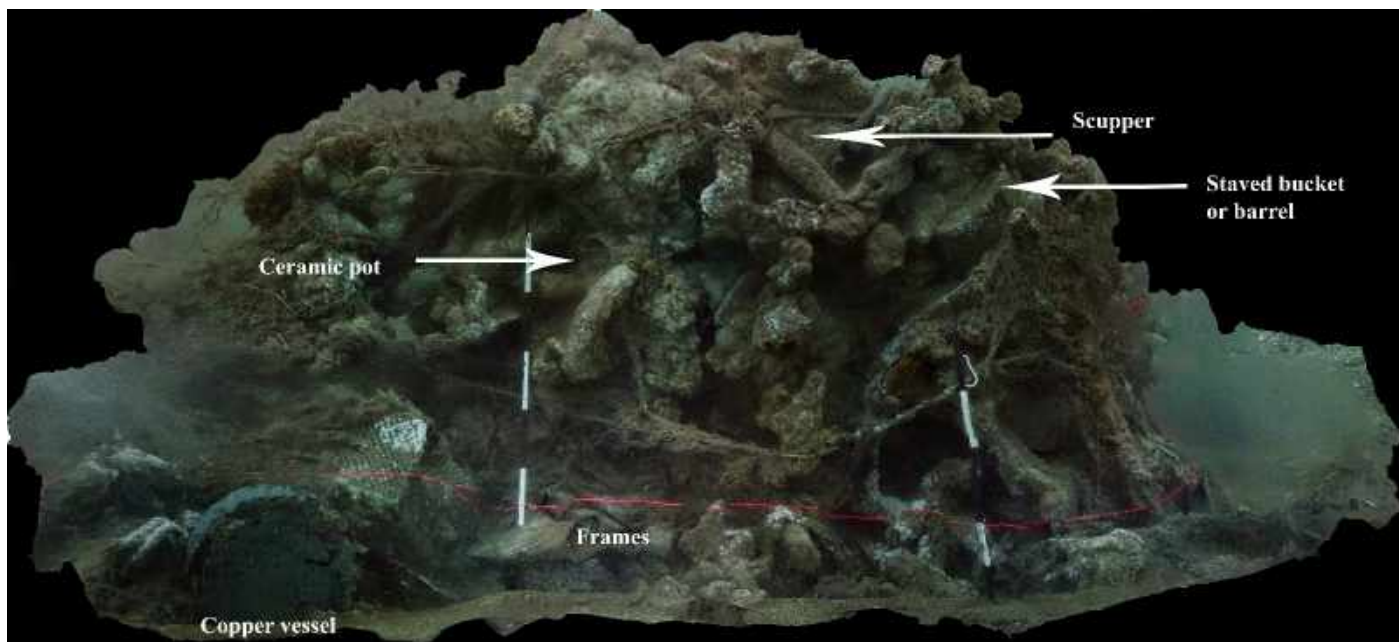
- 4.2.8. Above the timbers the concretion rises vertically by 2m. The face of the feature is heavily entangled with fishing gear, including a lobster pot, trawl and gill nets (Figure 4). On this section of the concretion it is possible to identify several objects. Near the top is a lead scupper 700mm long. It has a flange at one end on the outward side of the concretion. The external diameter of the scupper is 90mm (Figures 4 and 6). To the right of the scupper is a concreted barrel or a staved bucket. It is partially obscured by trawl netting. The diameter of the base is 330mm (Figures 4, 7 and 8). Below and to the left of the scupper is a small vessel, possibly ceramic (Figure 4). It has an external diameter of 150mm. These objects are surrounded by a mess of ferrous objects including shot, possible bar shot, iron rings and a mass of unidentifiable concretions of all shapes and sizes.

Figure 4: An orthophotomosaic of the west face of the concretion wall with annotations. The scales in the image are 1 metre with 20cm increments.

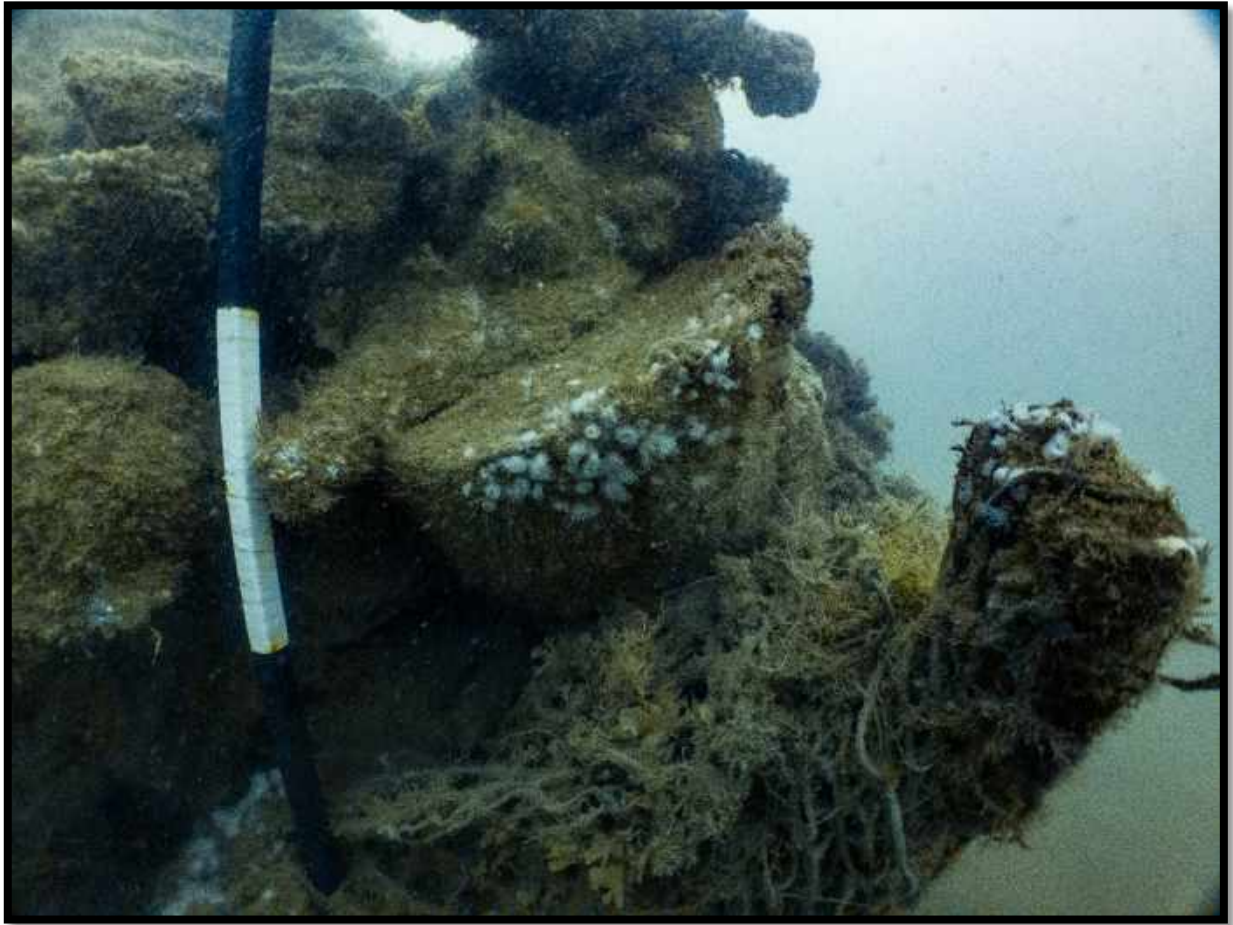
Figure 7: At the centre of the image a concreted staved bucket or barrel.

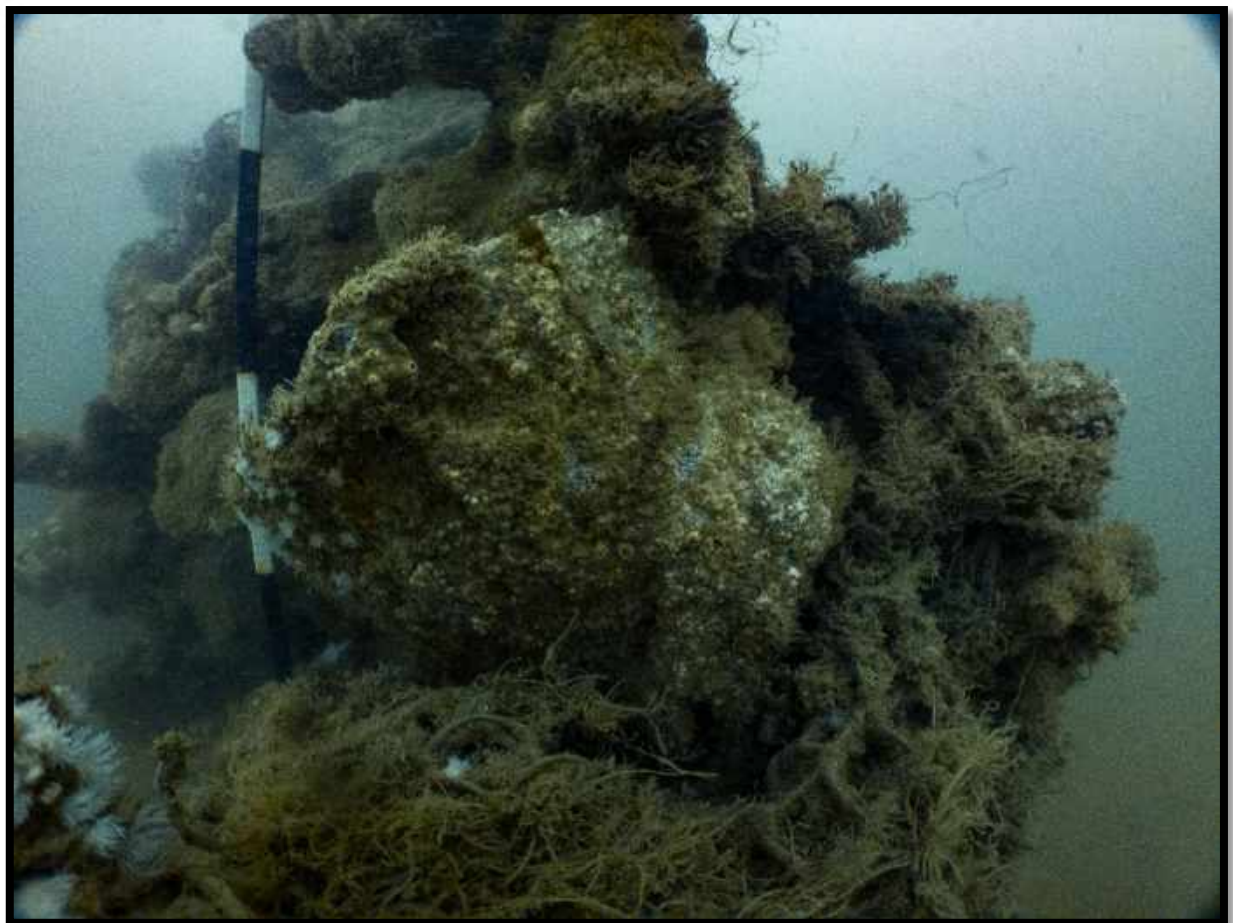
Figure 8: A side view of the concreted stave bucket or barrel.

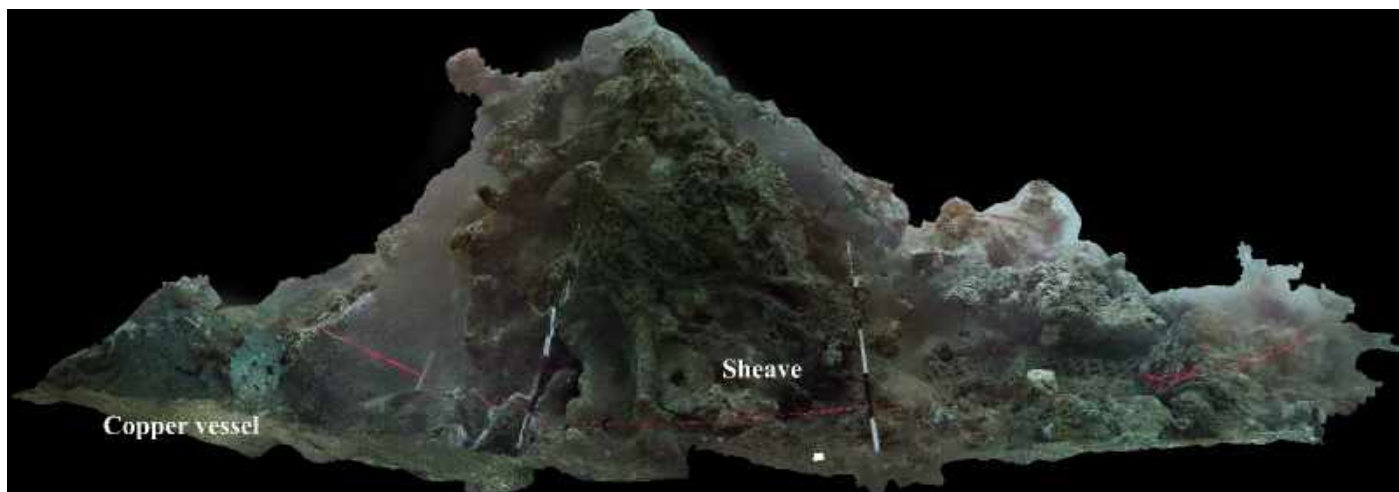
- 4.2.9. Moving round the concretion wall to the south face looking north, a large pulley sheave can be seen. It has a diameter of 300mm (just under 12 inches) and the hole for the pin has a diameter of 60mm (Figure 9). Above the sheave the face of the concretion is obscured by trawl netting. Just under two metres to the east, at seabed level, is at least one other pulley sheave. It is partially buried but looks equally as large as the previous. Once again there is a lot of trawl net covering this area of the concretion.

Figure 9: An orthophotomosaic of the south face of the wall of concretion. The scales are 1 metre with 20cm increments.

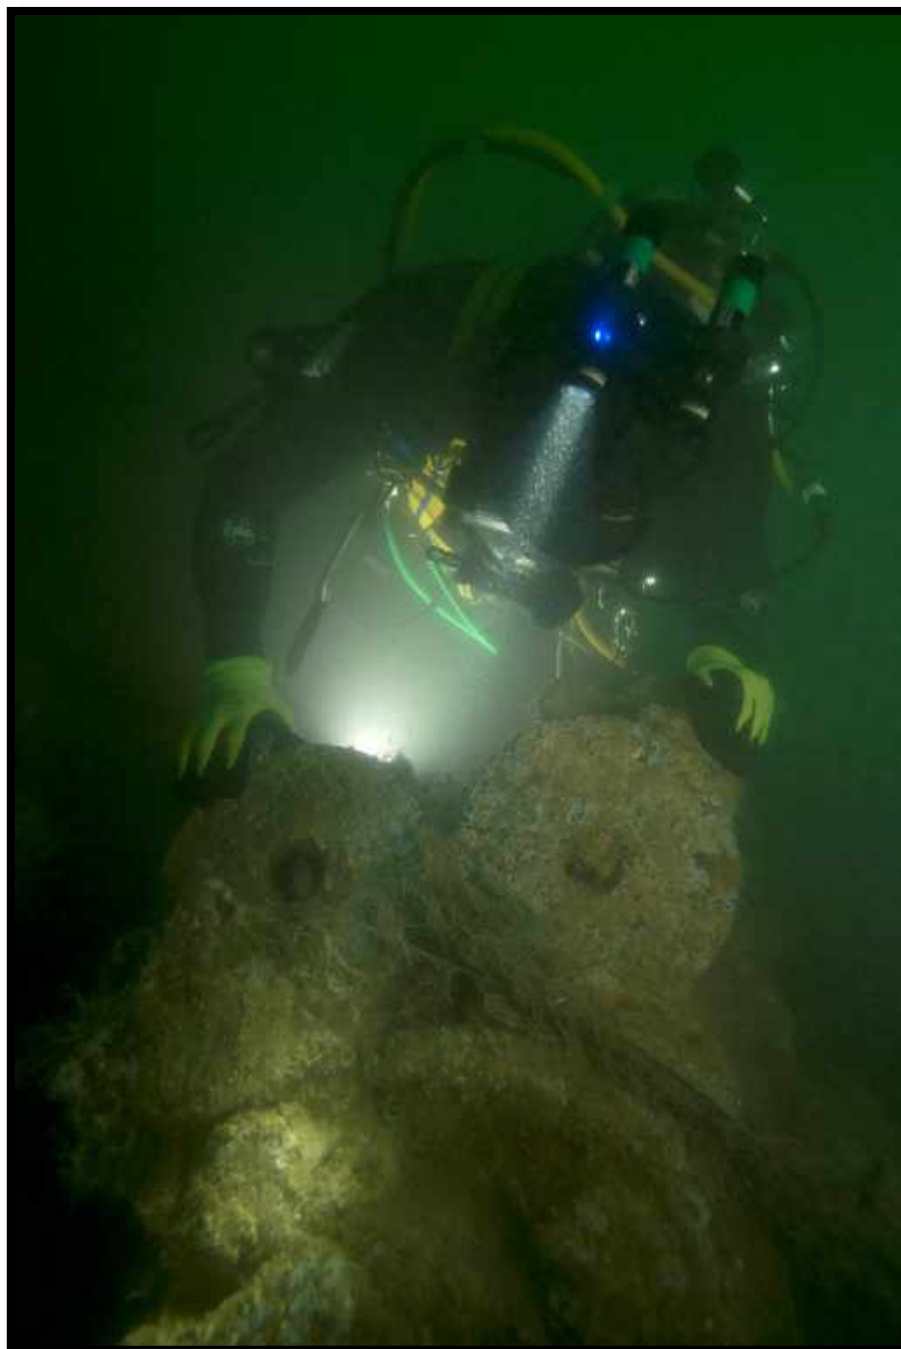
- 4.2.10. Continuing around the base of the concretion, approximately 3m to the northeast, is a concreted group of at least three pulley sheaves. The top two sheaves are clearly visible and have a diameter of 300mm, and a thickness of 60mm. The holes at their centres have a diameter of 60mm. Below these two sheaves, the edge of a third sheave can be made out. Tangled around the sheaves and surrounding concretion is gill netting with small floats attached. Further netting with floats can be seen coming out of the sand and floating up to 300mm above the surrounding seabed (Figures 10 and 11).

Figure 10: A diver inspecting a group of pulley sheaves at the SE end of the site. Photo by Michael Pitts.

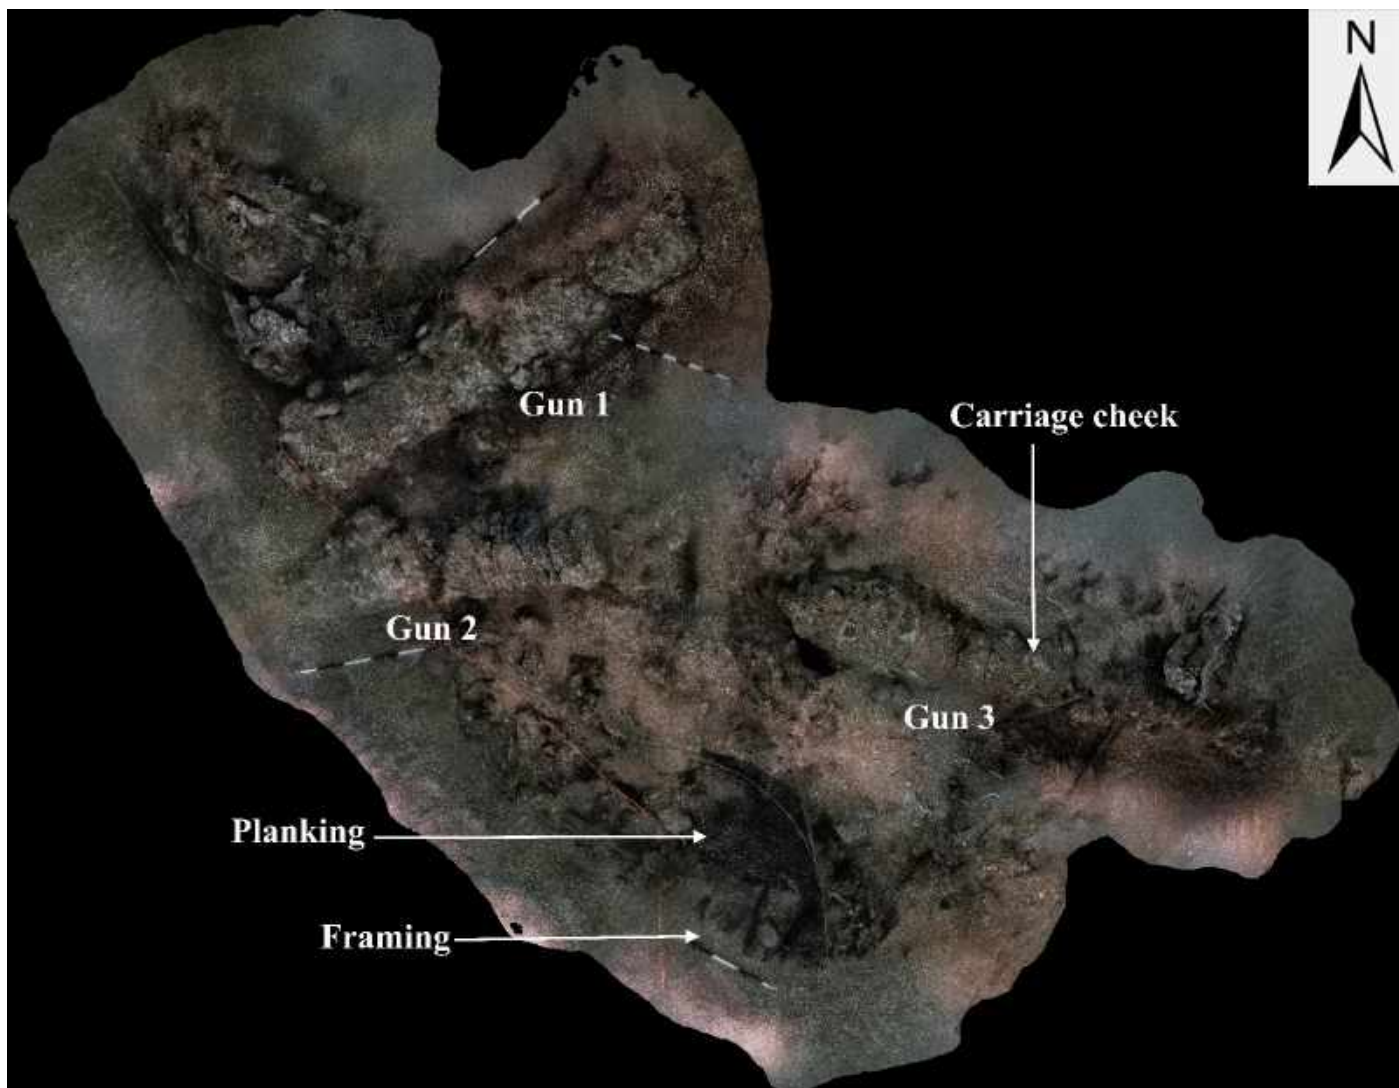
- 4.2.13. Moving 15m to the northwest from the previous area of concretions is an area consisting of three iron guns and a section of structure. This area was recorded photogrammetrically (Figure 13 and 15). The guns are all heavily concreted, so their measurements will be used only as a guide to help identification of their possible type. The guns have been labelled 1 to 3 for this assessment but attempts will be made to match them to guns recorded on previous site plans (Figure 14).

Figure 13: An orthophotomosaic of the group of three guns. The scales in the image are 1 metre with 10 and 20cm increments.

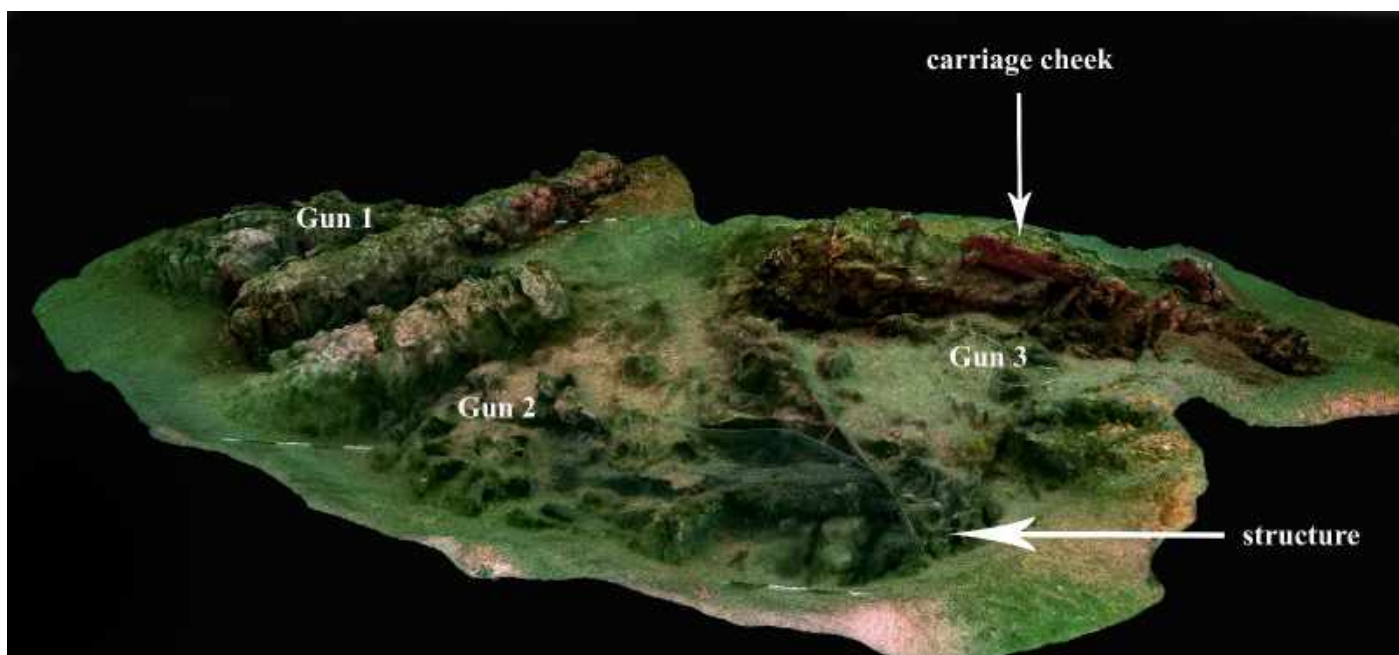
Figure 14: An image taken from the photogrammetry model of the guns. The scales in the image are 1m with 10 and 20cm increments.

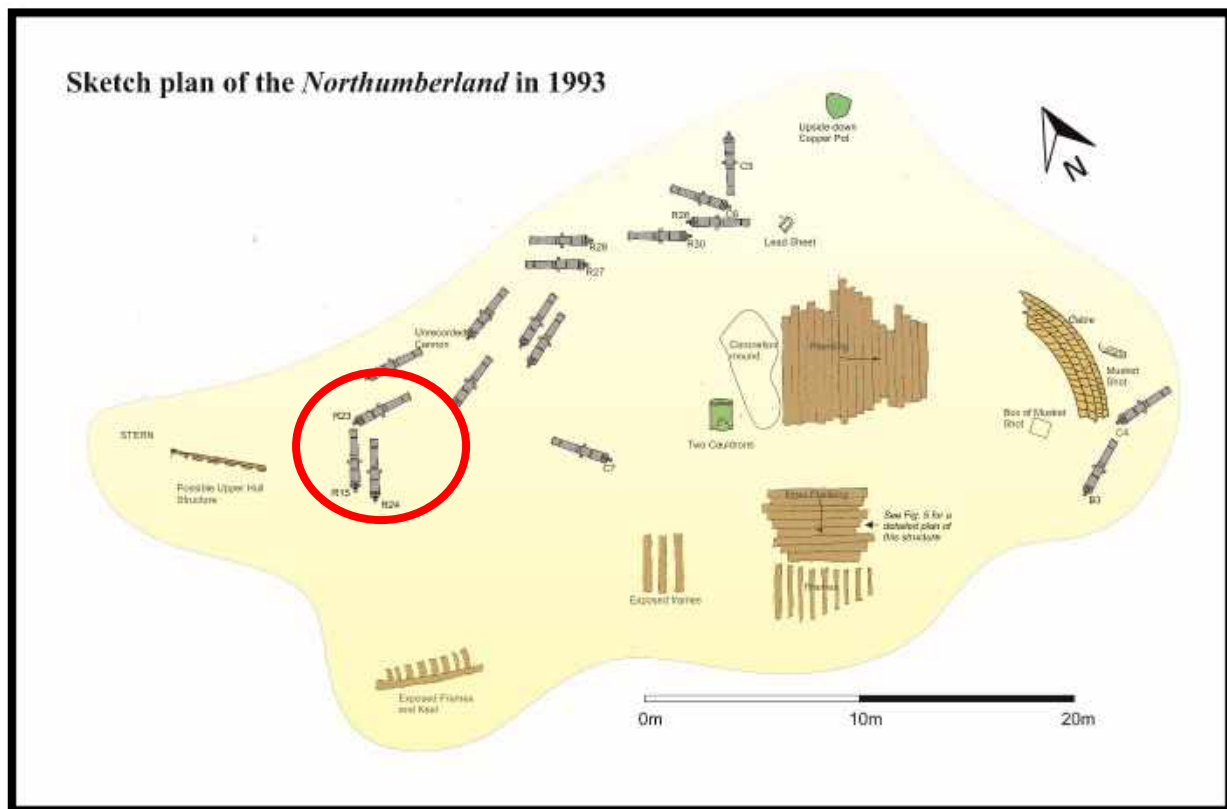
Figure 15: The 1993 sketch plan of the site. The red circle shows the group of guns under the current investigation

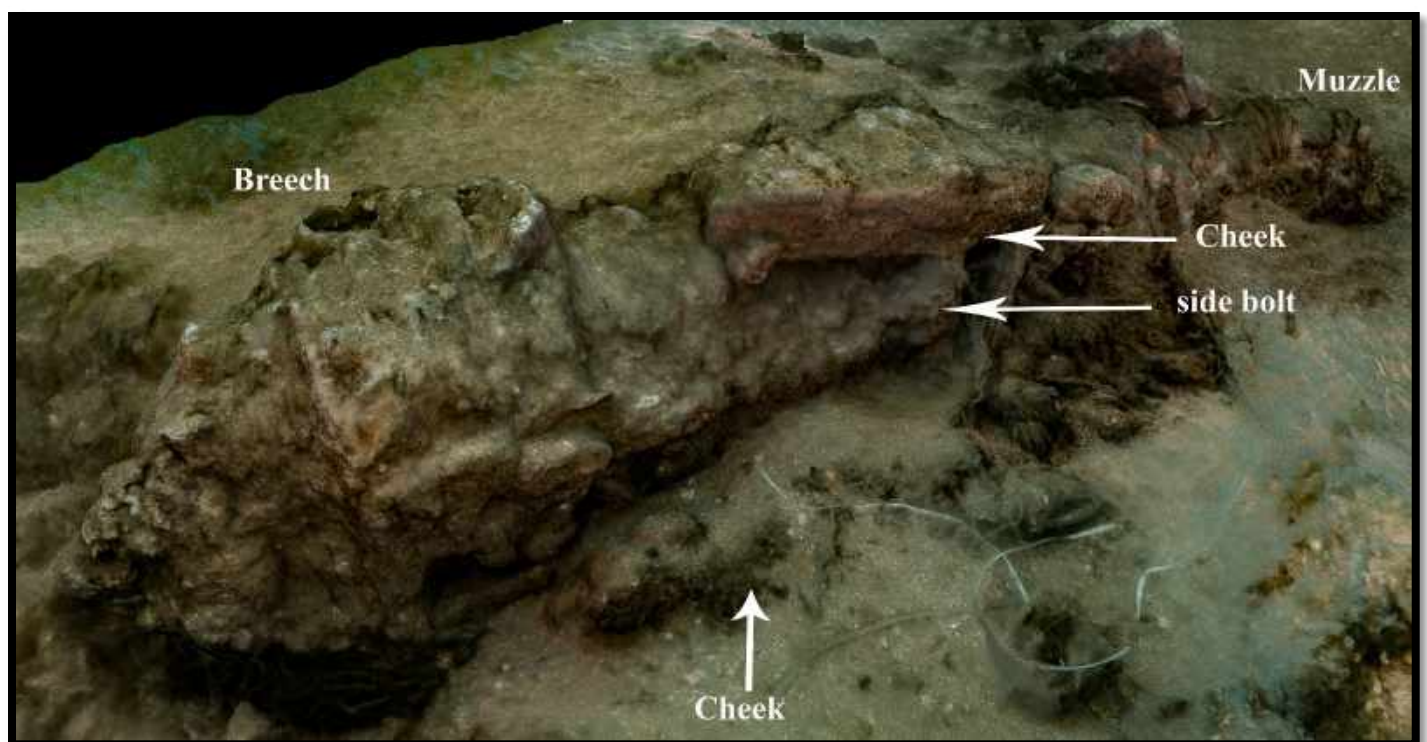
Figure 16: A photogrammetry model of Gun 3 showing the survival of parts of its associated gun carriage. The gun is lying on its side with the remains of parts of both cheeks present.

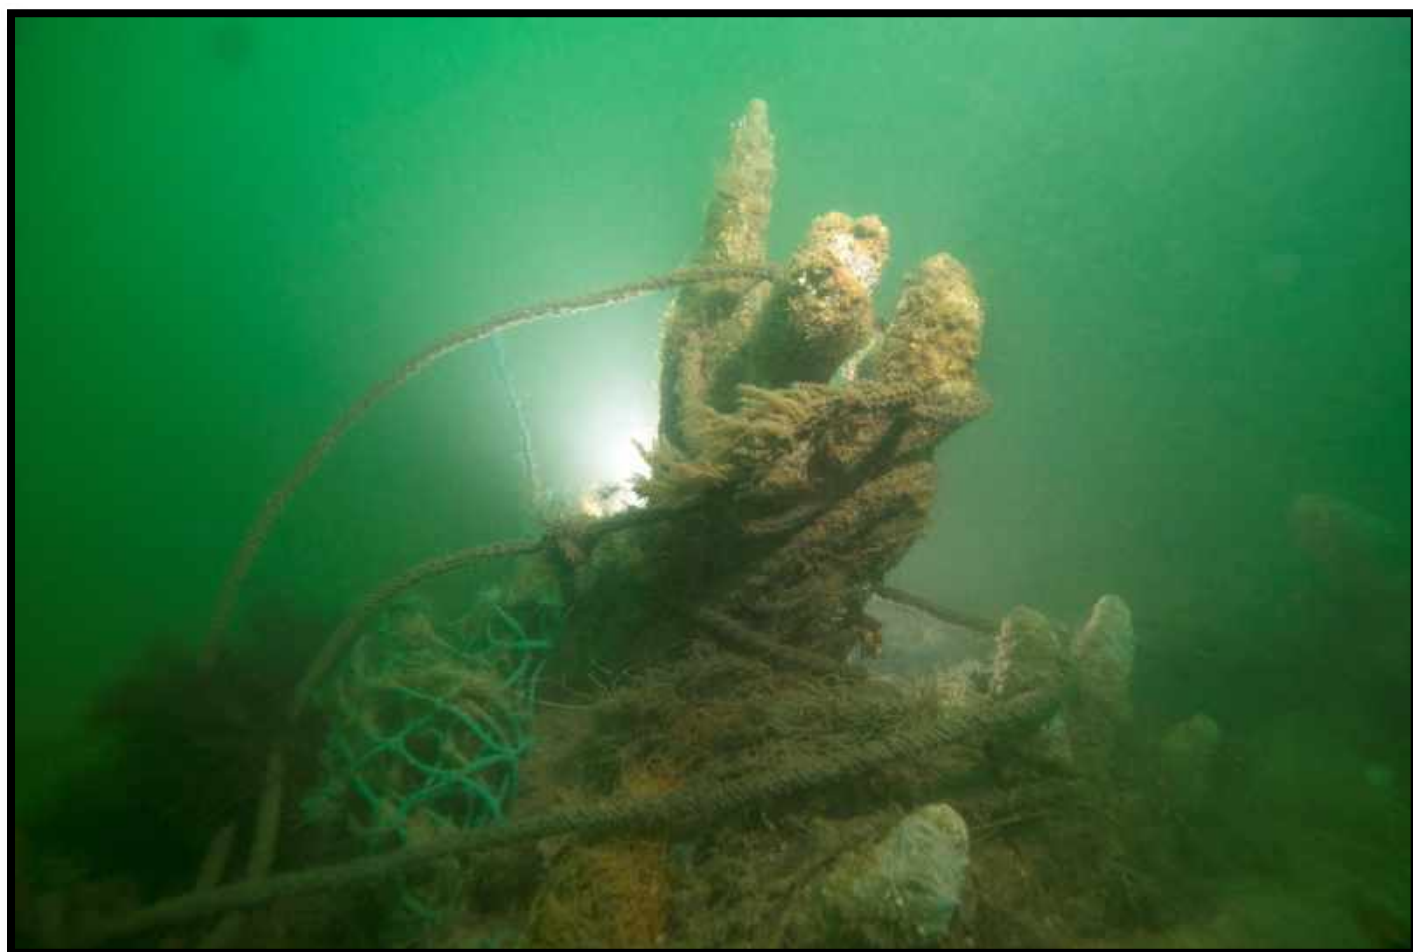
Figure 20: A photo showing the amount of fishing gear entangled around the assemblage. Photo by Michael Pitts.

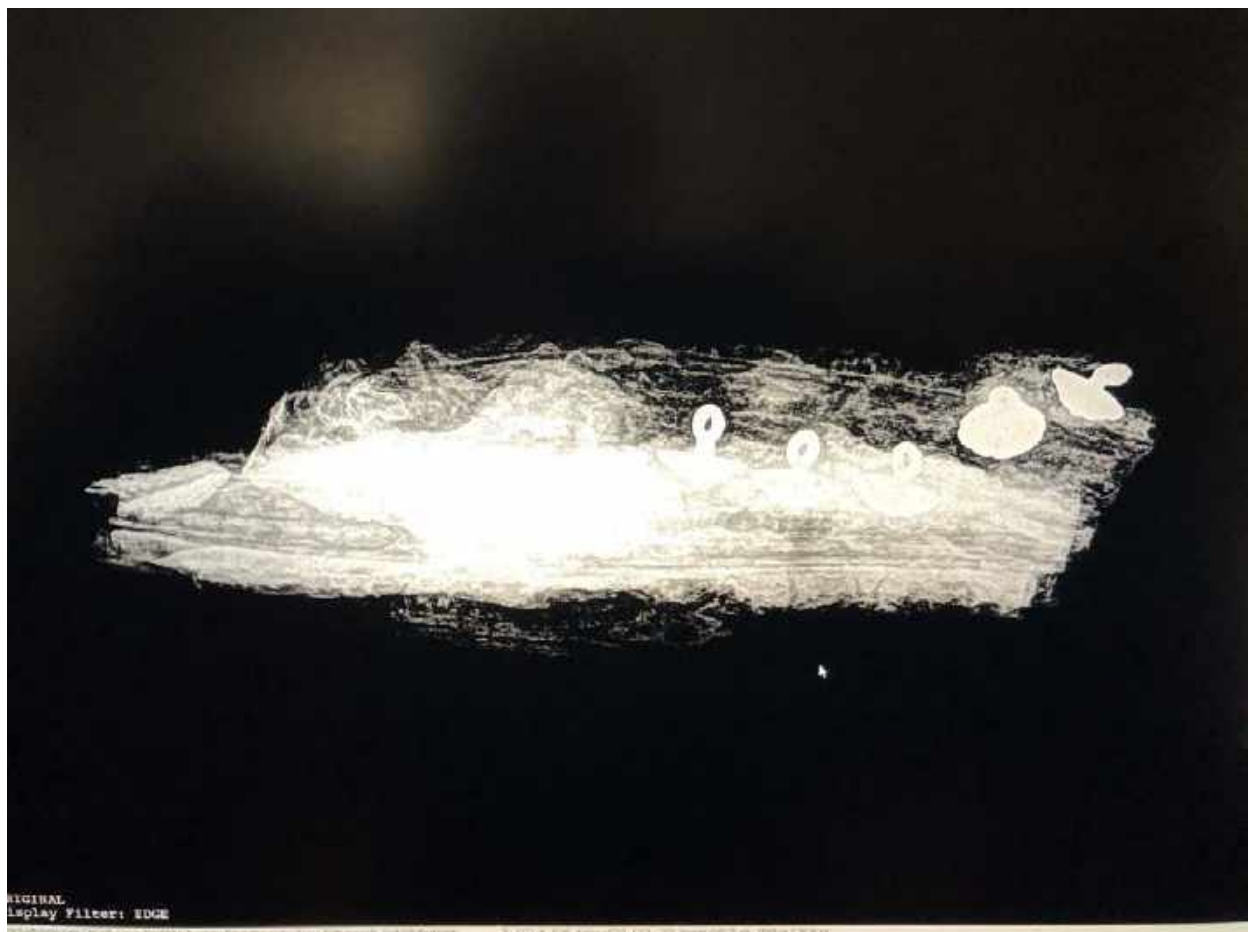
Figure 23: An X-ray identifying the ends of blades plus five metallic buttons in a row.
